33-11-001 , De-icing , Heated rear window

33-11-002, De-icing

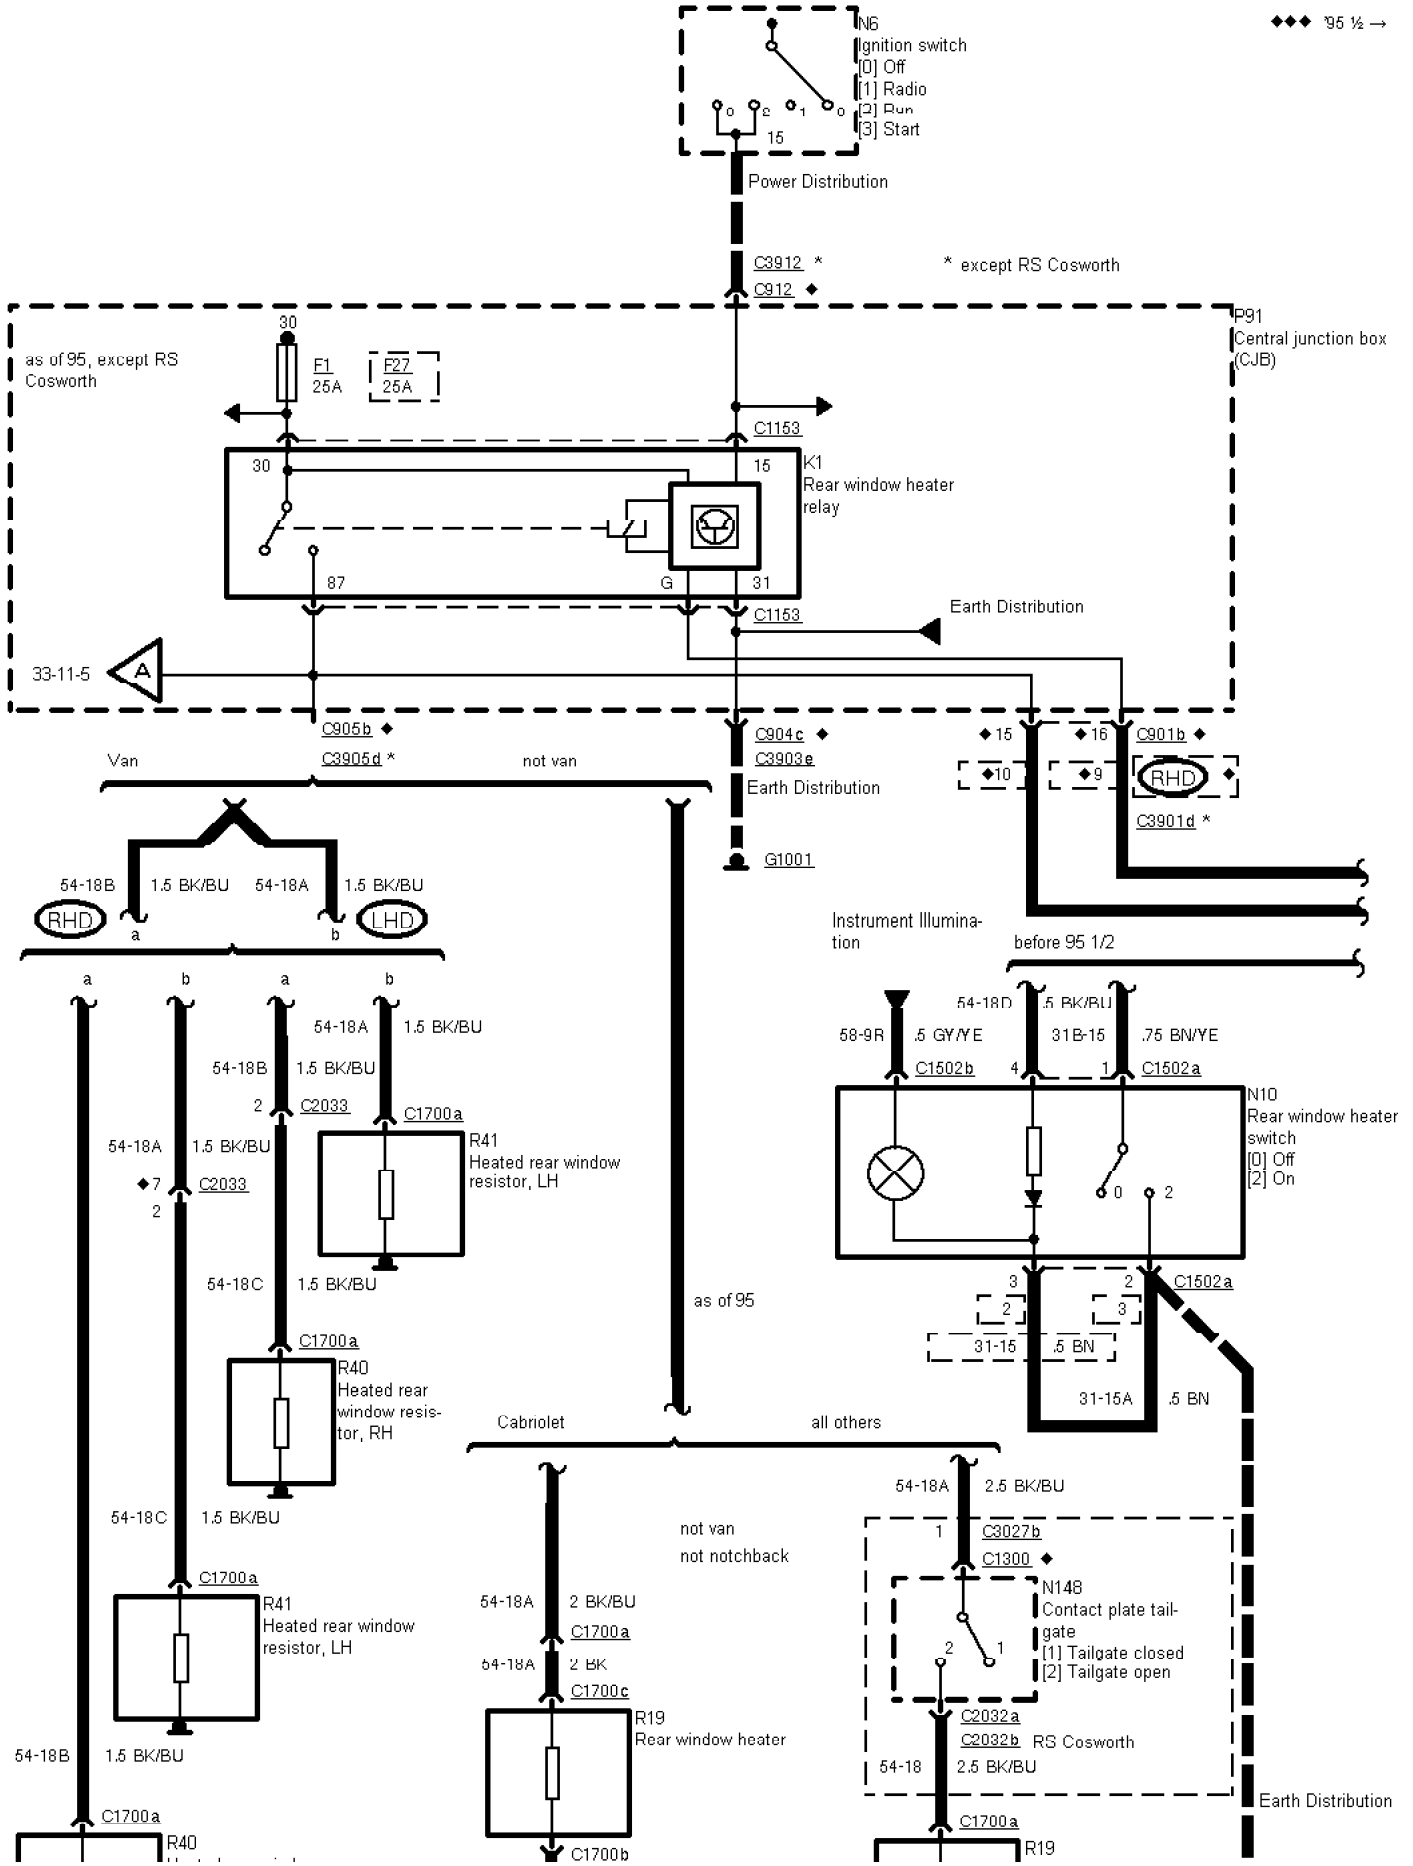
- ◆ → 95
- ◆◆ 95 → 95 1/2
- ◆◆◆ 95 1/2 →

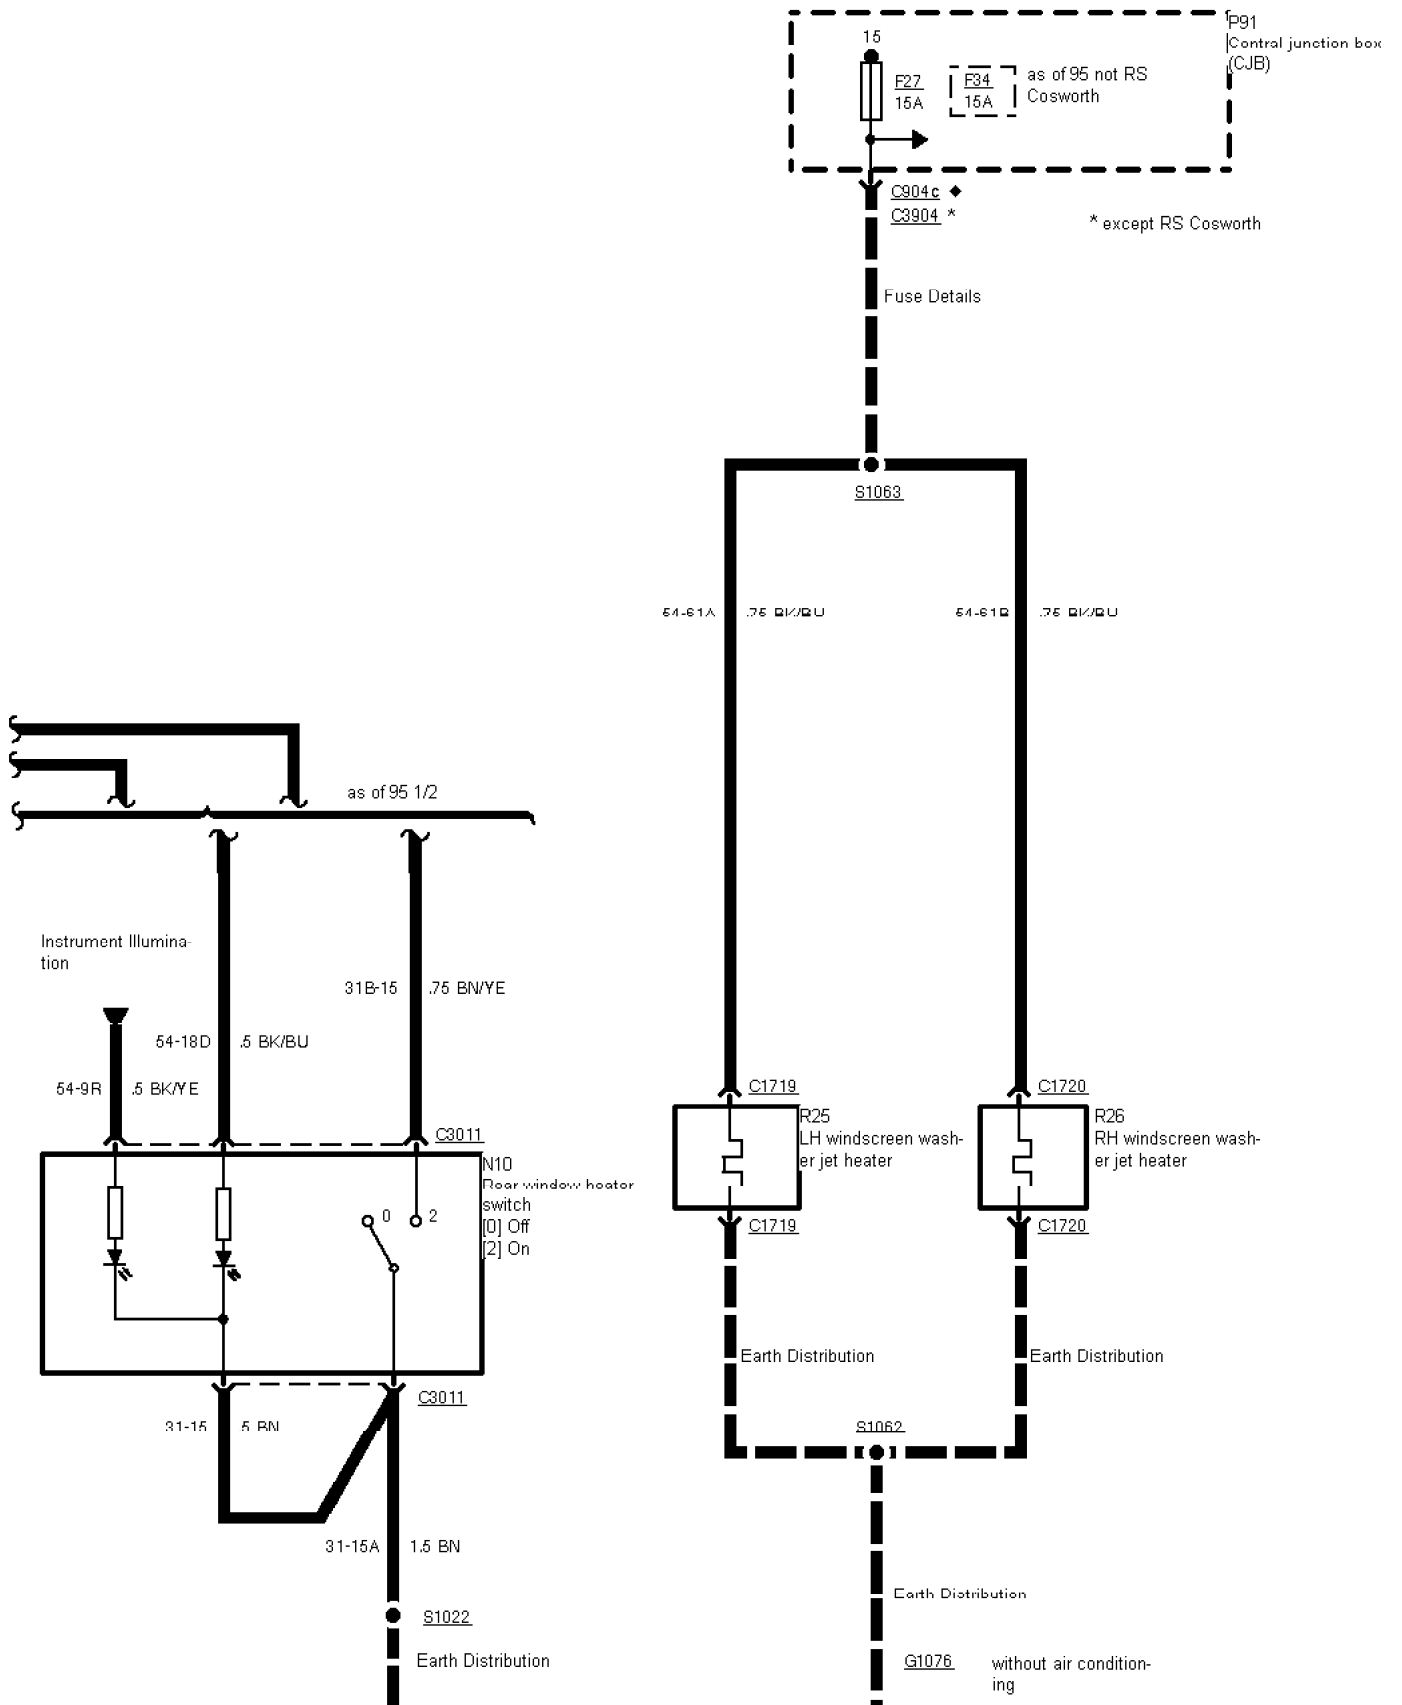
- ◆ → 95
- ◆◆ 95 → 95 1/2
- ◆◆◆ 95 1/2 →

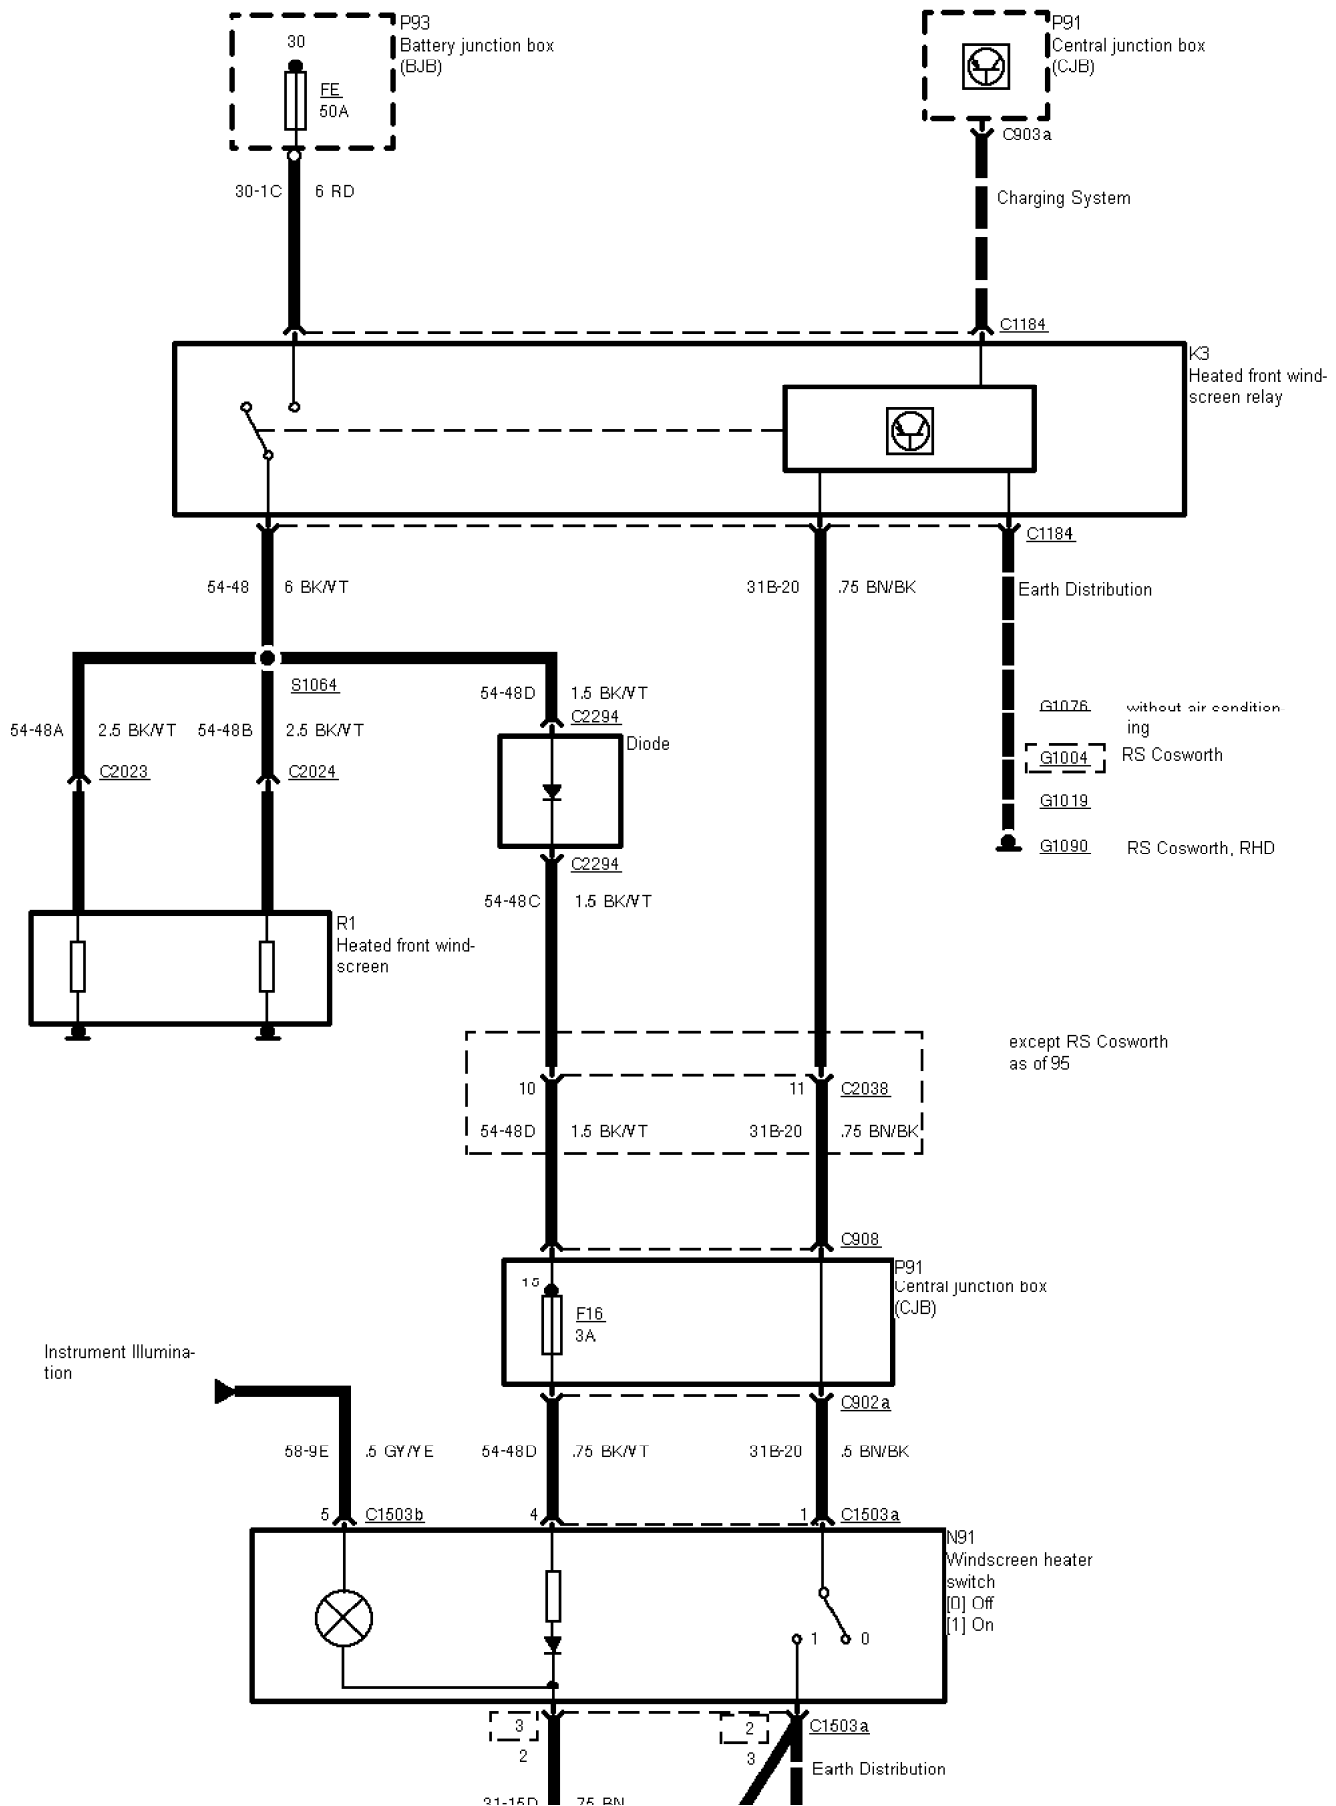
33-11-003 , De-icing , before 95, RS Cosworth Heated windscreen

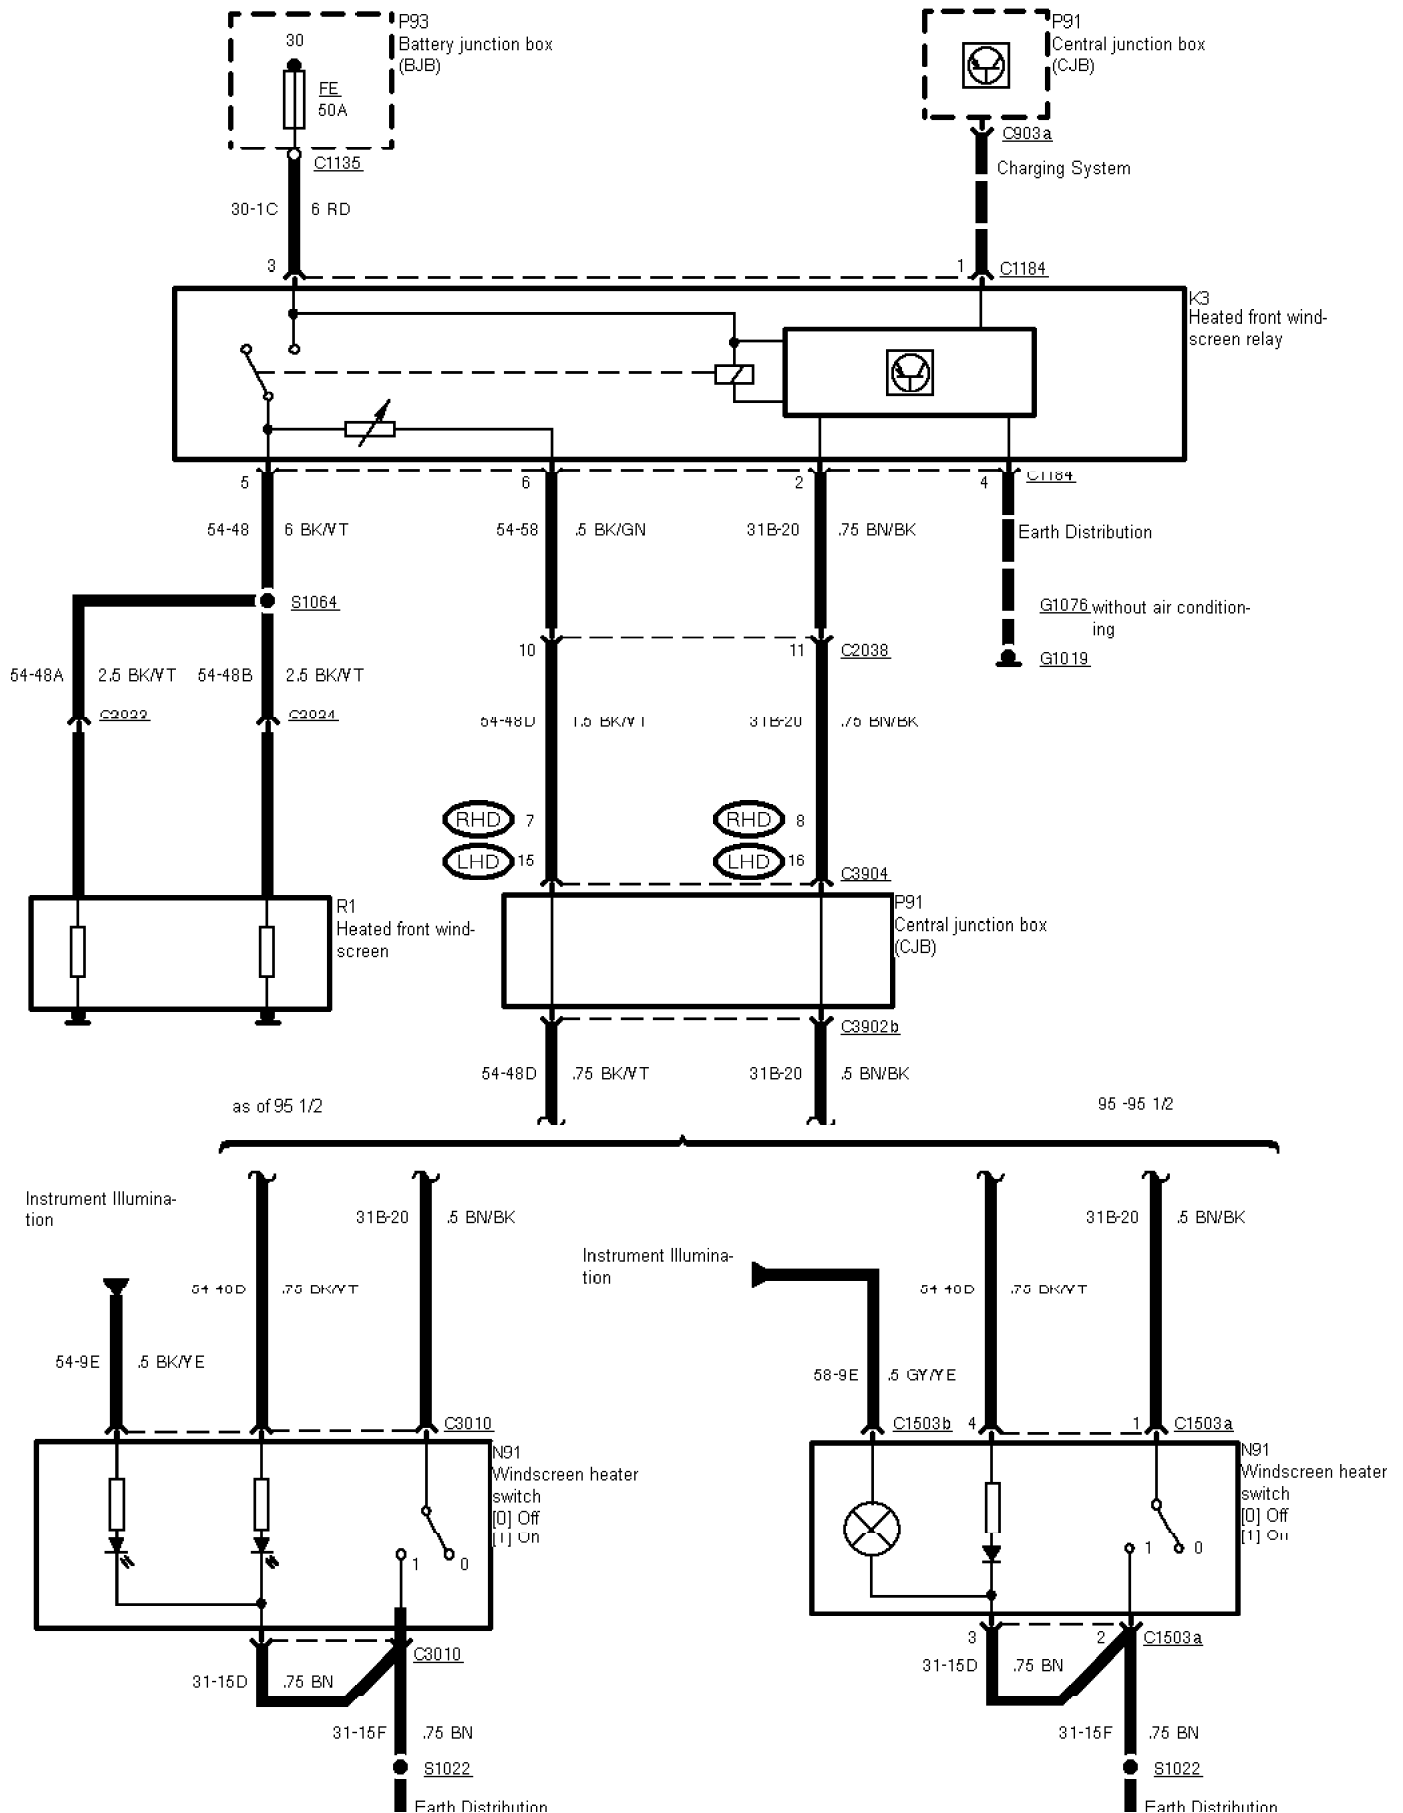
33-11-004 , De-icing , As of 95 without RS Cosworth Heated windscreen

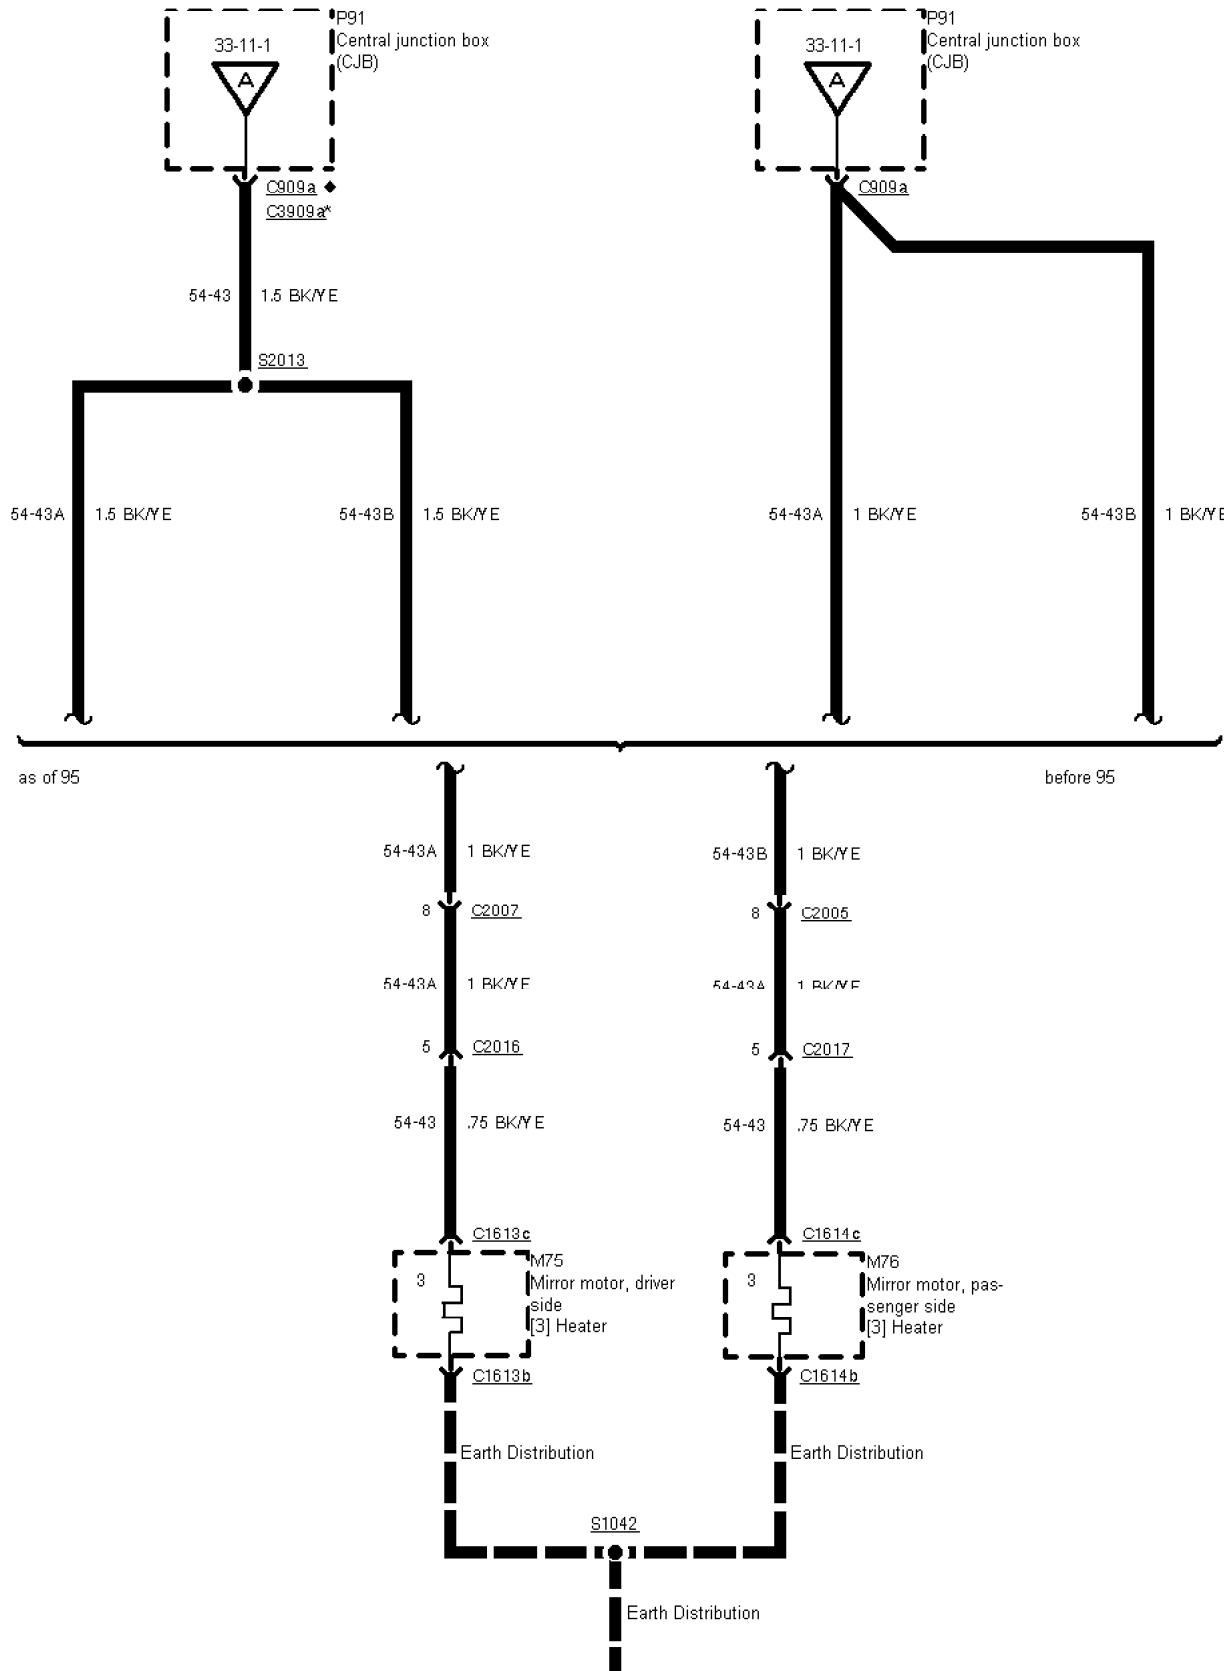
33-11-005 , De-icing , Heated mirrors

- ◆ → 95
- ◆◆ 95 → 95 ½
- ◆◆◆ 95 ½ →

* except RS Cosworth
