## Headlining (Saloon) - Renew (43 612 0)

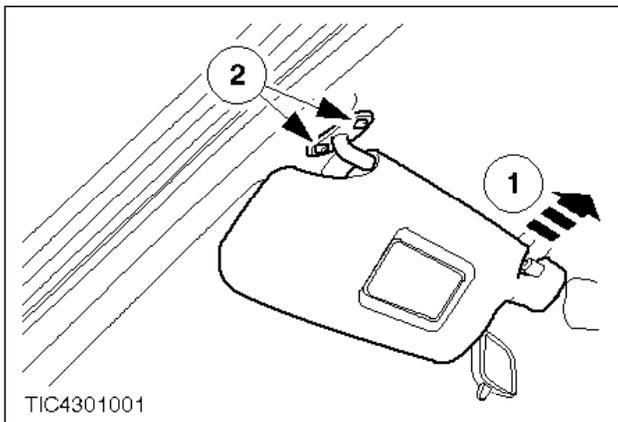
1. Remove the left and right-hand sun visors (four screws).
  - 1 Detach the sun visor from its retaining clip.
  - 2 Remove the two retaining screws.

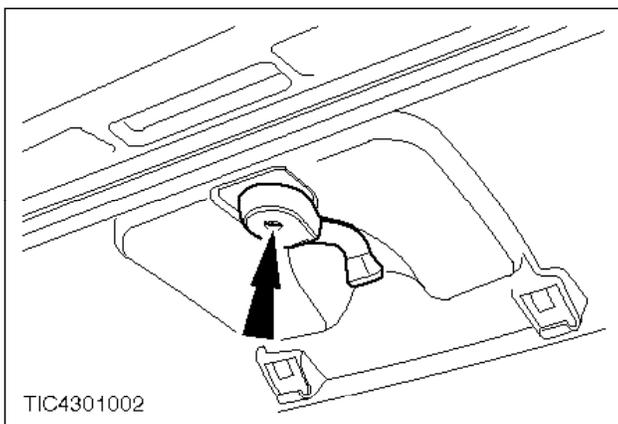
2. Remove the sliding roof handle (one screw).

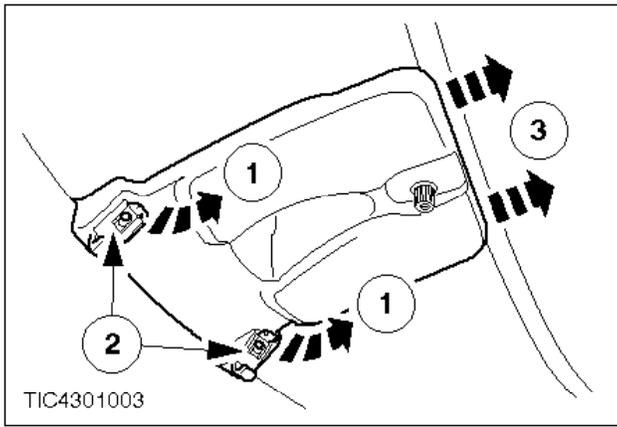
- ⌚ 3. Remove the overhead console (two screws and two clips).
- 1 Carefully prise open screw covers.
  - 2 Remove the two screws.
  - 3 Move the panel rearwards to disengage the clips.

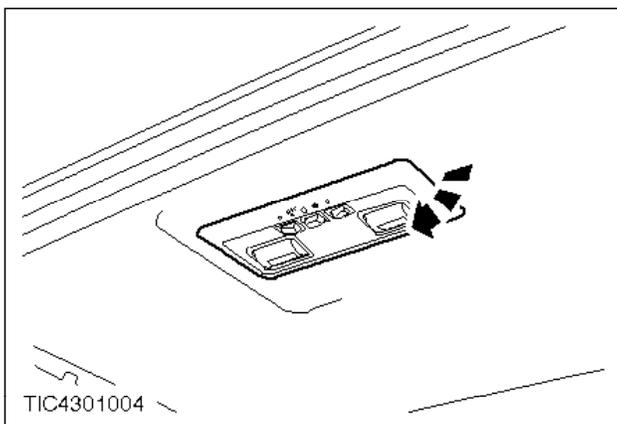
- ⌚ 5. Remove the interior lamp.
- Carefully detach the interior lamp from the headlining.

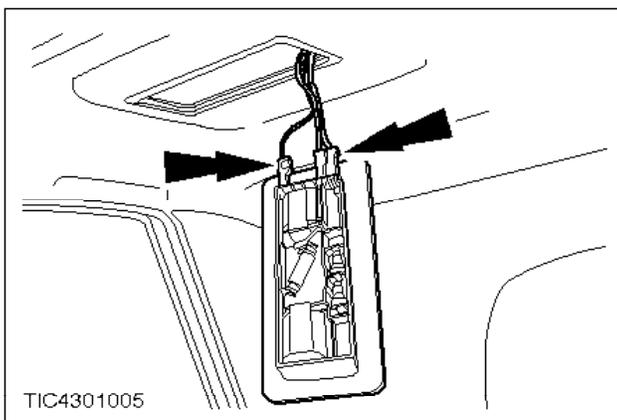
- 6. Disconnect the multiplugs and remove the interior lamp assembly.

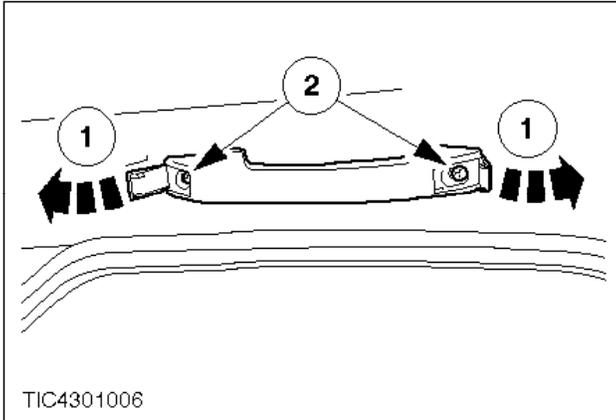
- 7. Remove the three passenger assist handles.
  - 1 Carefully prise open the screw covers.
  - 2 Remove the passenger assist handle (two screws).

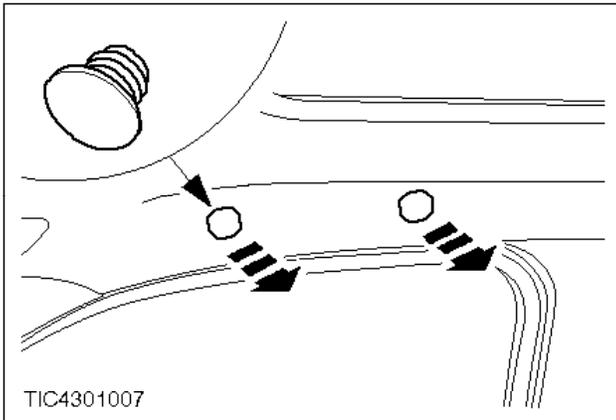
- 8. Remove the two blanking plugs from the headlining above the driver door.
- 9. Remove the left and right-hand A-pillar trim panels (refer to [«Operation Number 43 616 0»](#)).
- 10. Remove the left and right-hand B-pillar trim panels (refer to [«Operation Number 43 617 0»](#)).

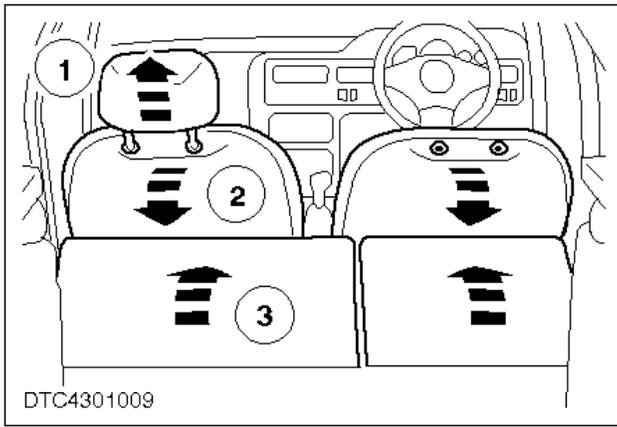
- 11. Remove the head restraints from the front seats (and rear head restraints when fitted). Lower the seat backs and remove the parcel shelf to facilitate headlining removal.

- 1 Remove the head restraints.
- 2 Lower the front seat backs.
- 3 Lower the rear seat backs and remove the parcel shelf.

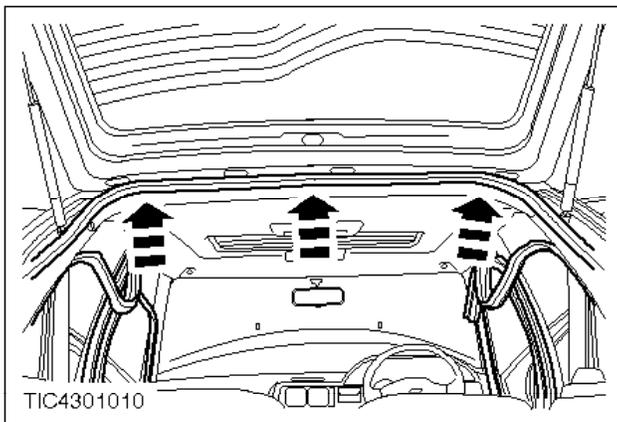
The tailgate weatherstrip should be positioned outside the aperture to facilitate removal of the headlining.

- 13. Locally detach the door and tailgate weatherstrips.

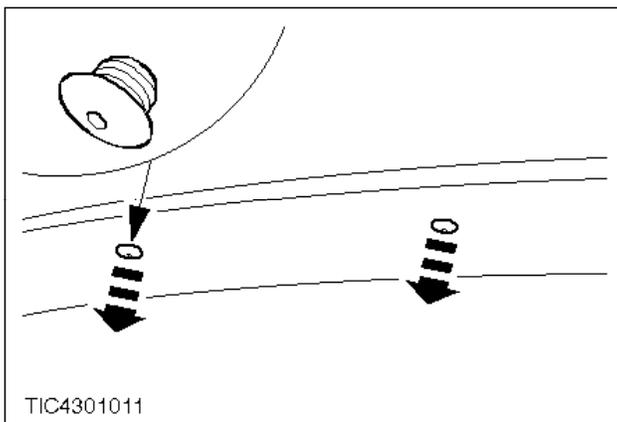
With the help of another technician, support the headlining.

- 14. Remove the two rear headlining retaining clips.

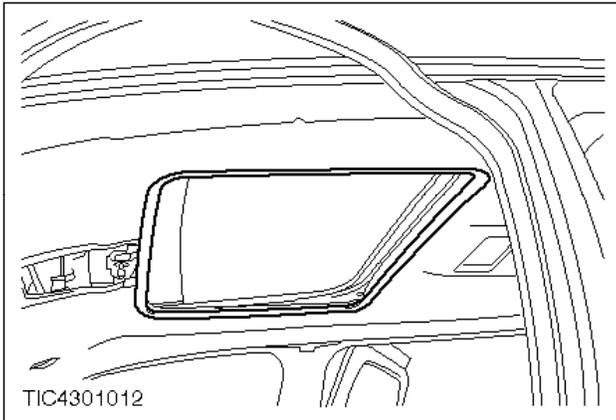
- 15. Remove the sliding roof surround.

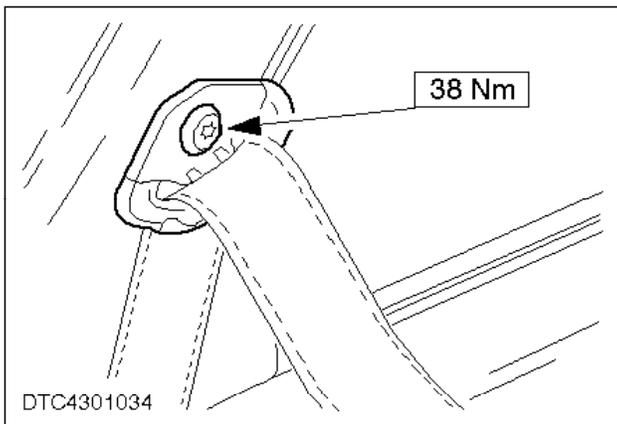
- 17. Refit the components in reverse order.  
Handle - Passenger Assist - Install (43 655 0)  
Lamp - Interior - Install (33 112 0)  
Sun Visor - Install (43 633 0)
